**Development of a methodology for evaluating  
the structural integrity of reinforced concrete elements  
and other building materials**

**ANASTASIOS C. MPALASKAS**  
DIPL. CIVIL ENGINEER

Thesis for the degree of  
DOCTOR OF PHILOSOPHY

**IOANNINA 2016**

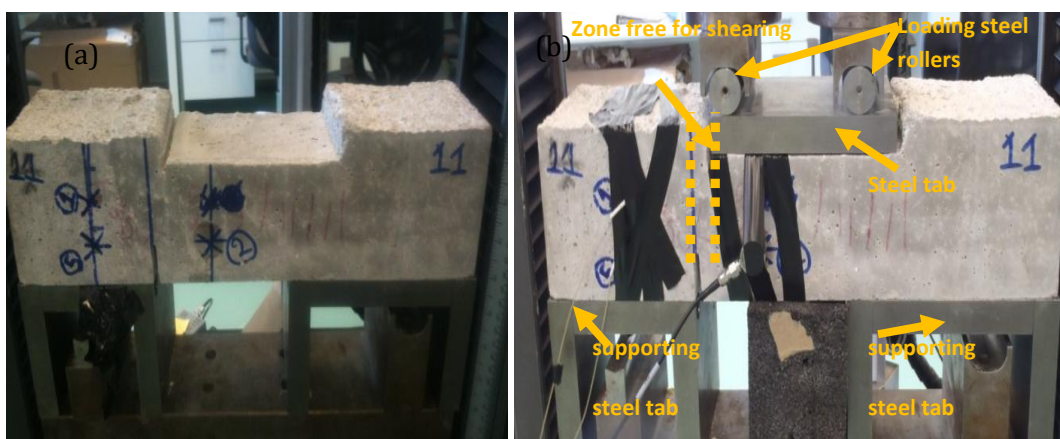
**Figure 3.2. 2** (a) Concrete beam with reduced cross section for shear testing, (b) test set up for the shear testing.

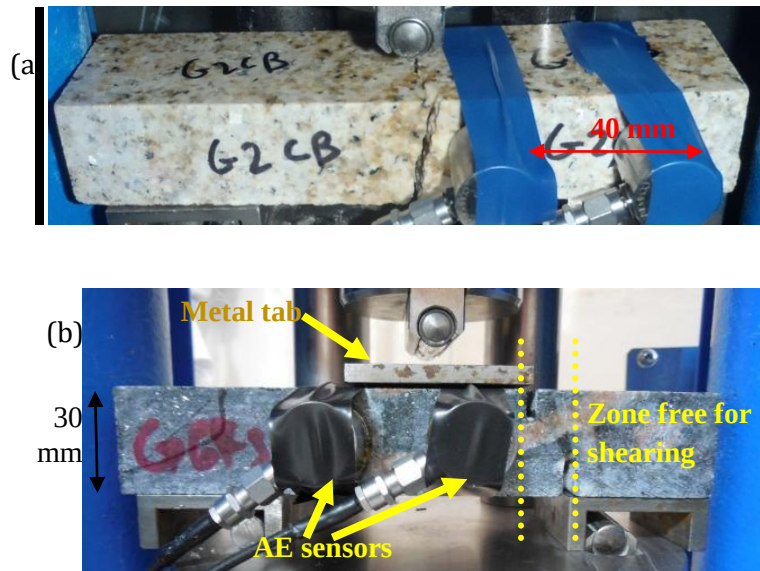
**Figure 3.5. 1** (a) Three point bending and (b) shear test of granite with concurrent AE monitoring by two sensors.

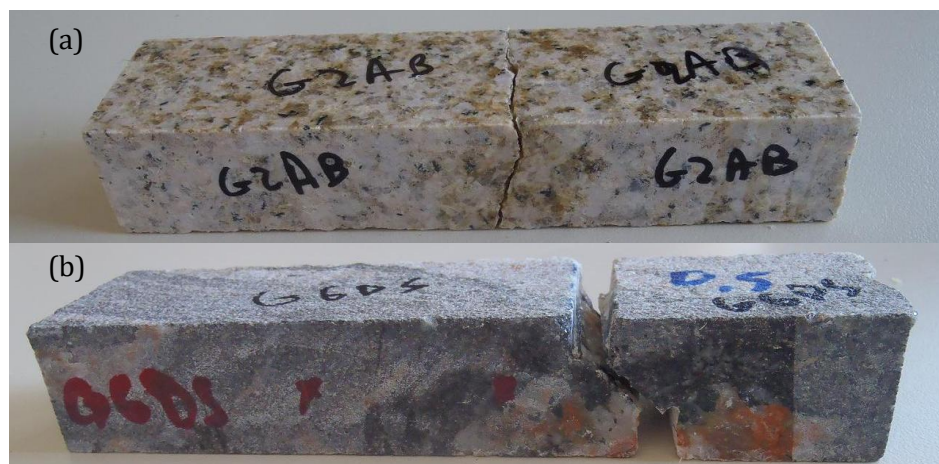
**Figure 3.5. 4** Typical specimens after fracture (a) bending, (b) shear.

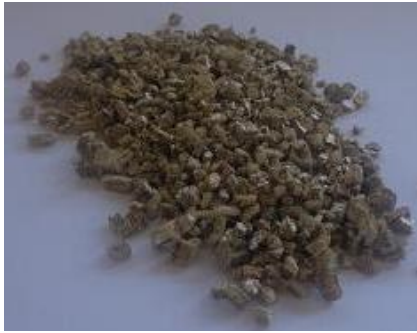
**Figure 5. 1** *Particles used as simulated damage*

Seven different mortar mixtures were produced consisting of three specimens each. One was plain mortar (PM, including cement sand and water) and the others additionally included 1.5%, 2.5%, 5.0%, 7.5%, 10.0% and 12.5% (vol.) of light nearly-spherical expanded polystyrene inclusions (see Figure 5. 1) acting as voids.

The average inclusions size was 3.9 mm as measured from a population of twenty particles. Sand grains were of 4.75 mm maximum size, while the water to cement ratio was 0.70 by mass. The density and the water absorption of the sand were 2500 kg/m<sup>3</sup> and 2.44% respectively. The exact mix proportions of PM were as follows: cement type (II 42.5 N) 440 kg/m<sup>3</sup>, water 308 kg/m<sup>3</sup>, sand 1364 kg/m<sup>3</sup>, super-plasticizer 4.5 kg/m<sup>3</sup>. For mortar with simulated damage the corresponding amount of inclusions was added in the mixer to account for the prescribed volume content, while the other parameters were modified accordingly so that to keep water to cement and sand to cement ratios constant. An idea of the microstructure at the scale of the inclusions, air bubbles and grains is shown in the photograph of Figure 5. 2 where the cross section of a specimen with 12.5% inclusions is included.

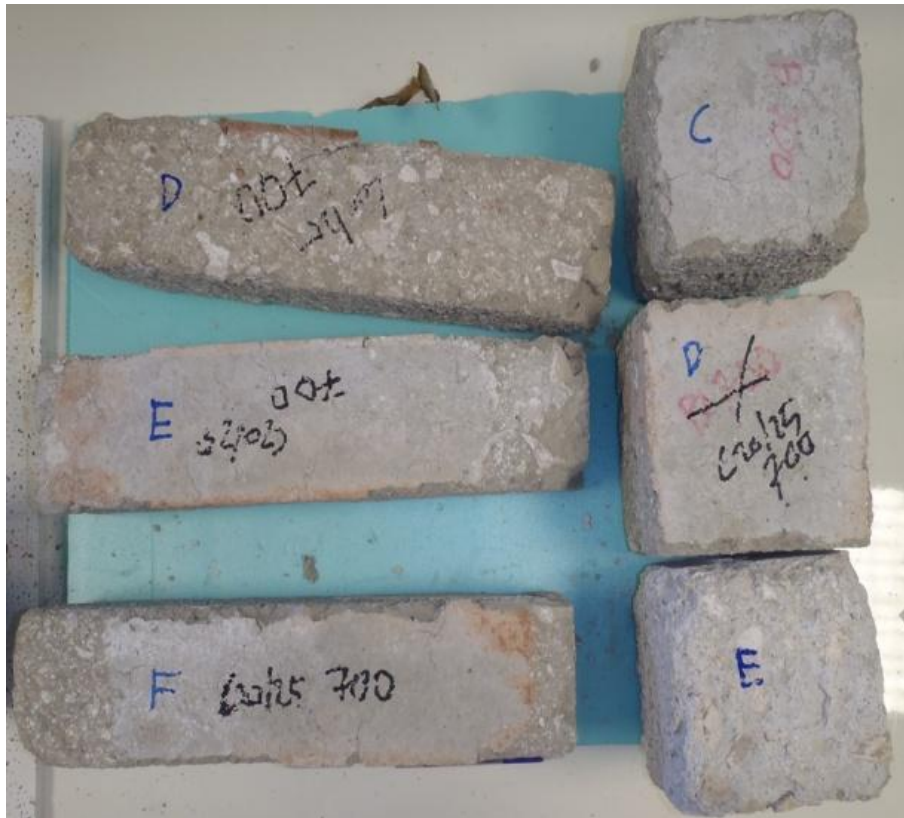
**Figure 6. 1** Typical specimens after fire exposure.

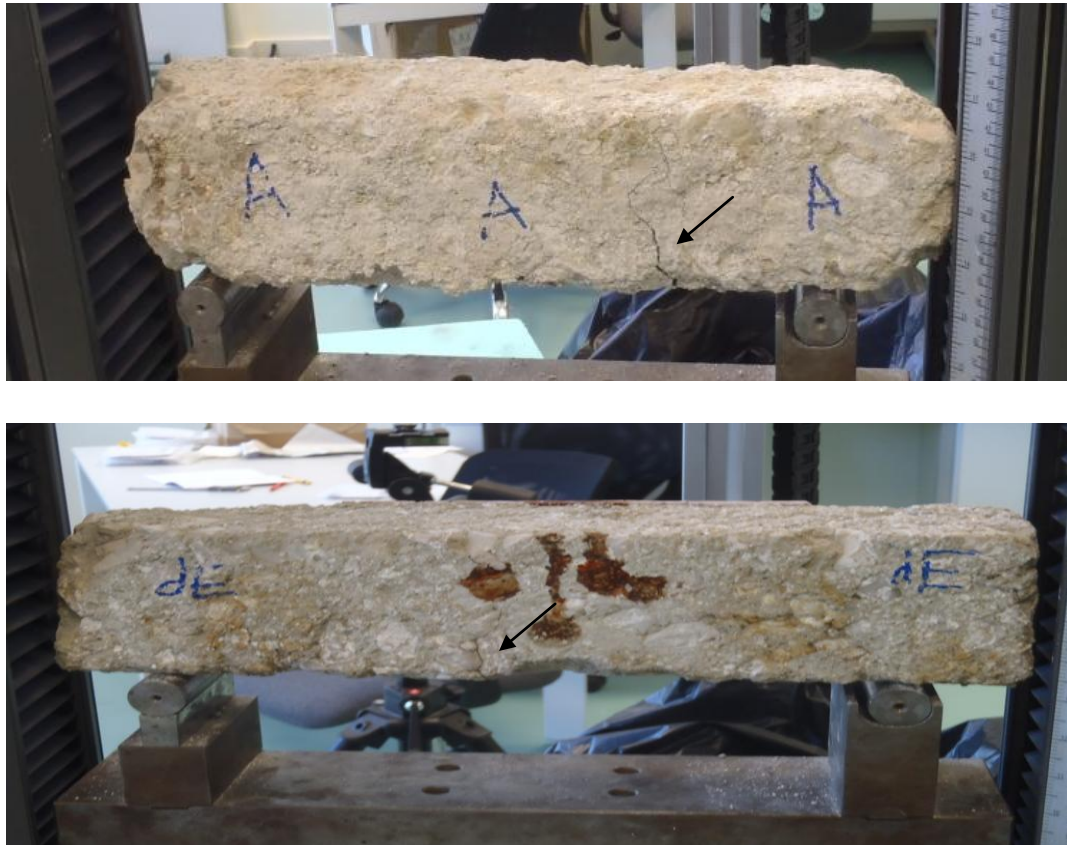
**Figure 6. 5** *Bending specimen after the four-point bending test. A large crack is visible (see arrow).*

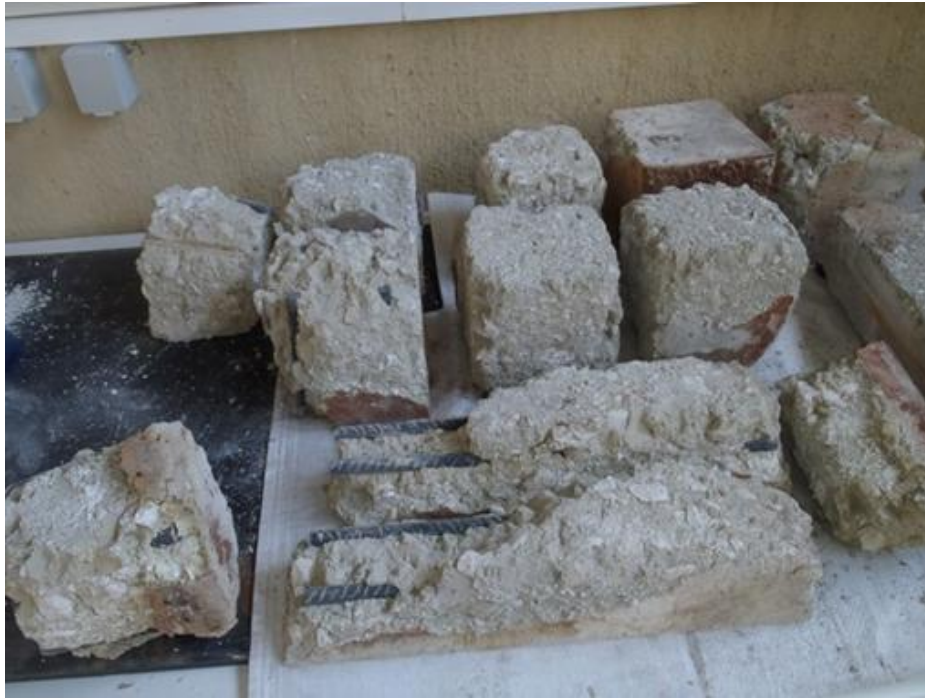
**Figure 7. 1** *Damaged reinforced concrete specimens after fire exposure.*
